Title: Wind resistance testing of Shadow Line+ cladding incorporating Envello Décor

Report No: N950-23-18585

Customer: Millboard Company Limited
Unit A, Castle Court,
Bodmin Road, Coventry CV2 5DB

Issue date: 18 December 2023

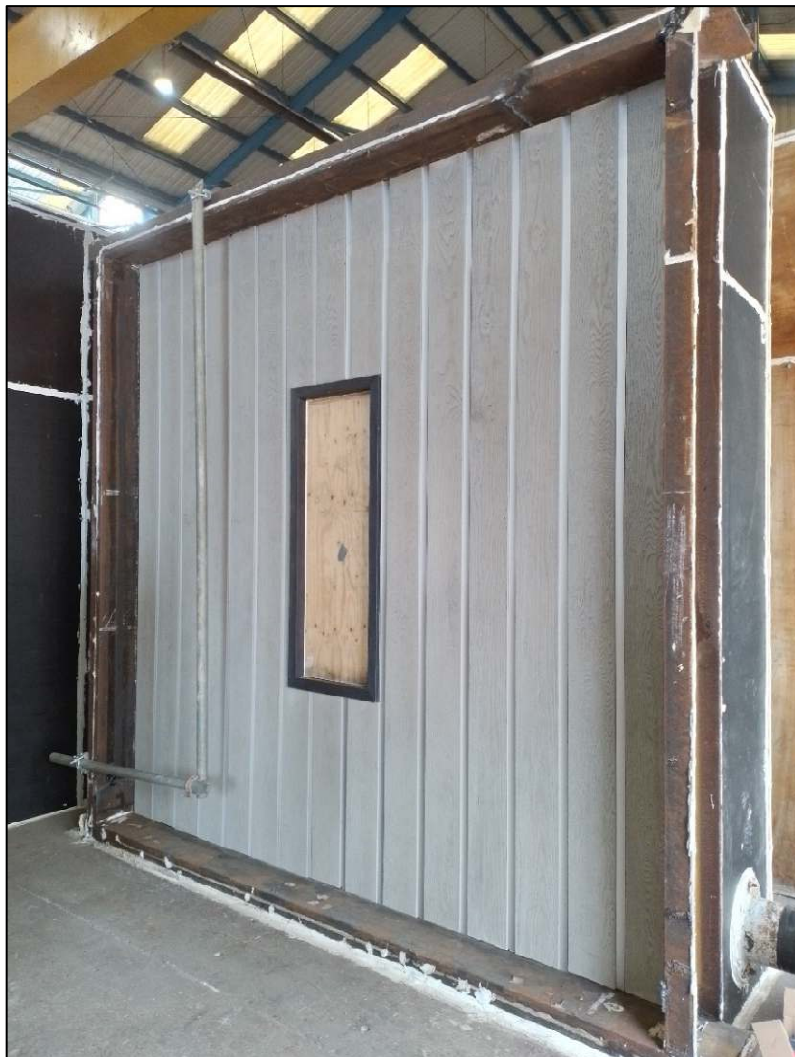
PHOTO 105829

The sample was as shown in the drawings and the photograph below and measured 3.0 m x 3.0 m.

The boards were fitted in the vertical orientation, fixed to timber battens with an example window inserted into the centre of the construction. In between every cladding board was an Envello Décor decorative strip, with both 16 & 32mm width used across the panel. The battens were set at 400mm centres max, with battens fully lining the window opening.

The Envello Décor strips were fixed to the battens with 30mm Envello Board fixings through the fixing flange for half of the construction, the other half of the panel the Décor strips were nailed onto the battens with 25mm ring shank nails. Where the cladding board tongue was taken off (around the window or at the edges) the boards were fixed to the battens with 16g brad nails.

The window reveal was lined with reveal boards, these were fixed to the timber battens with 16g brad nails.

TEST SAMPLE ELEVATION

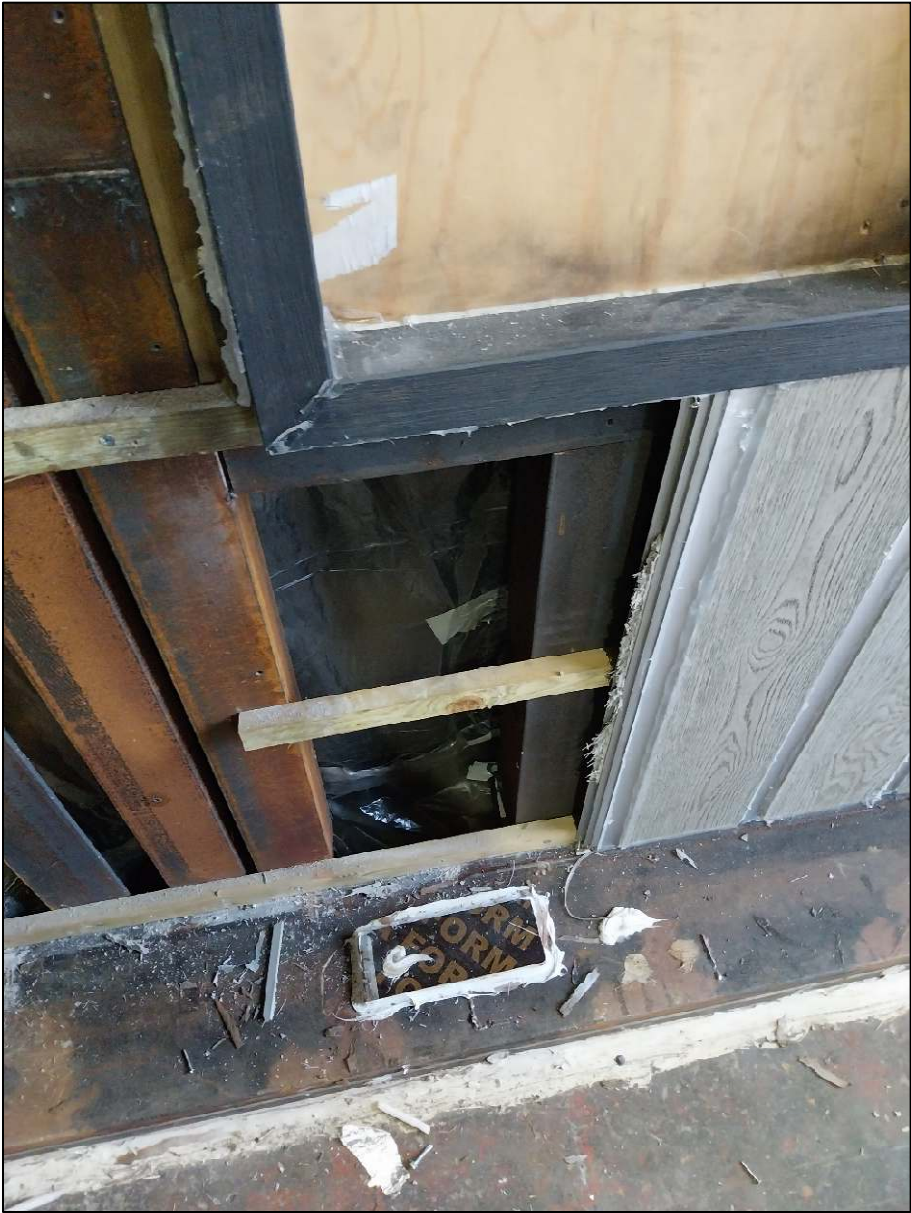
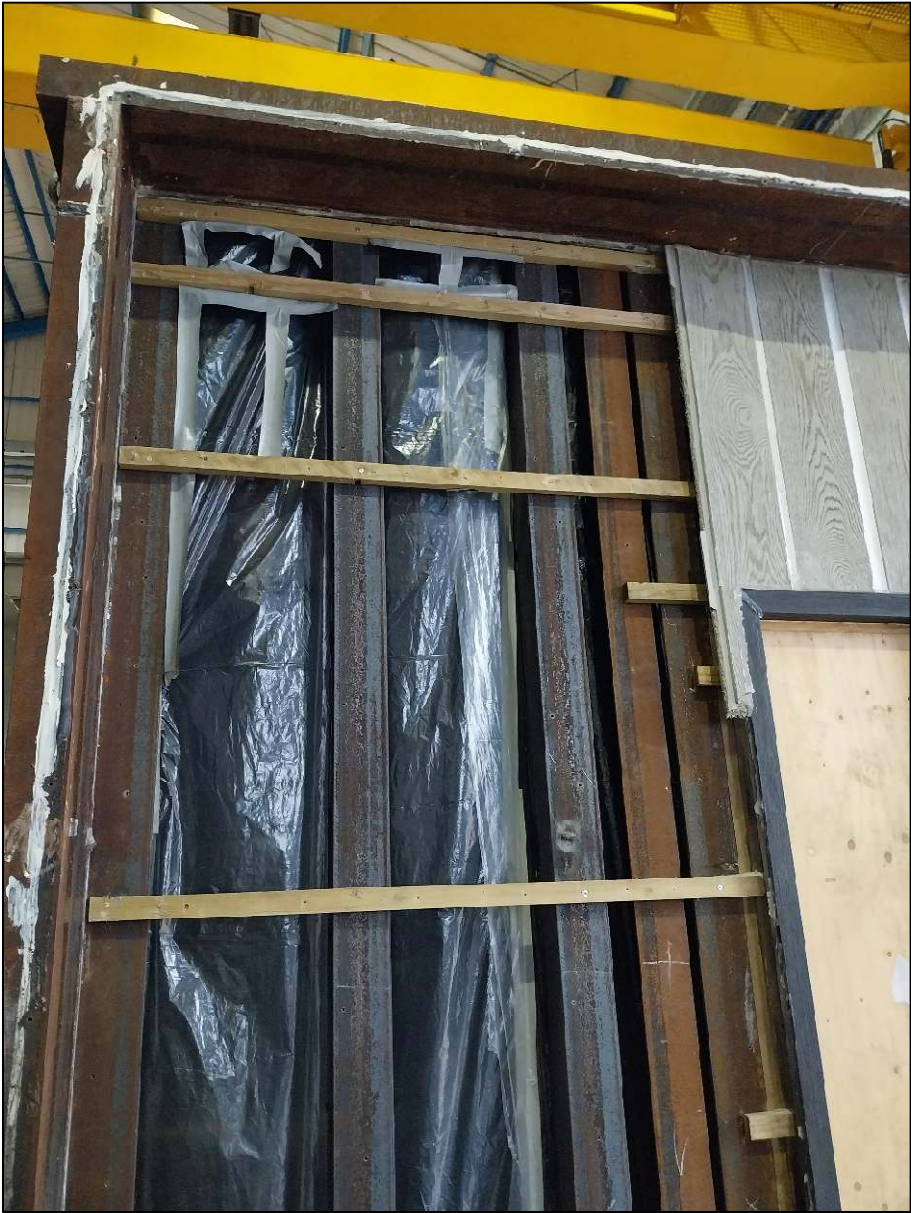
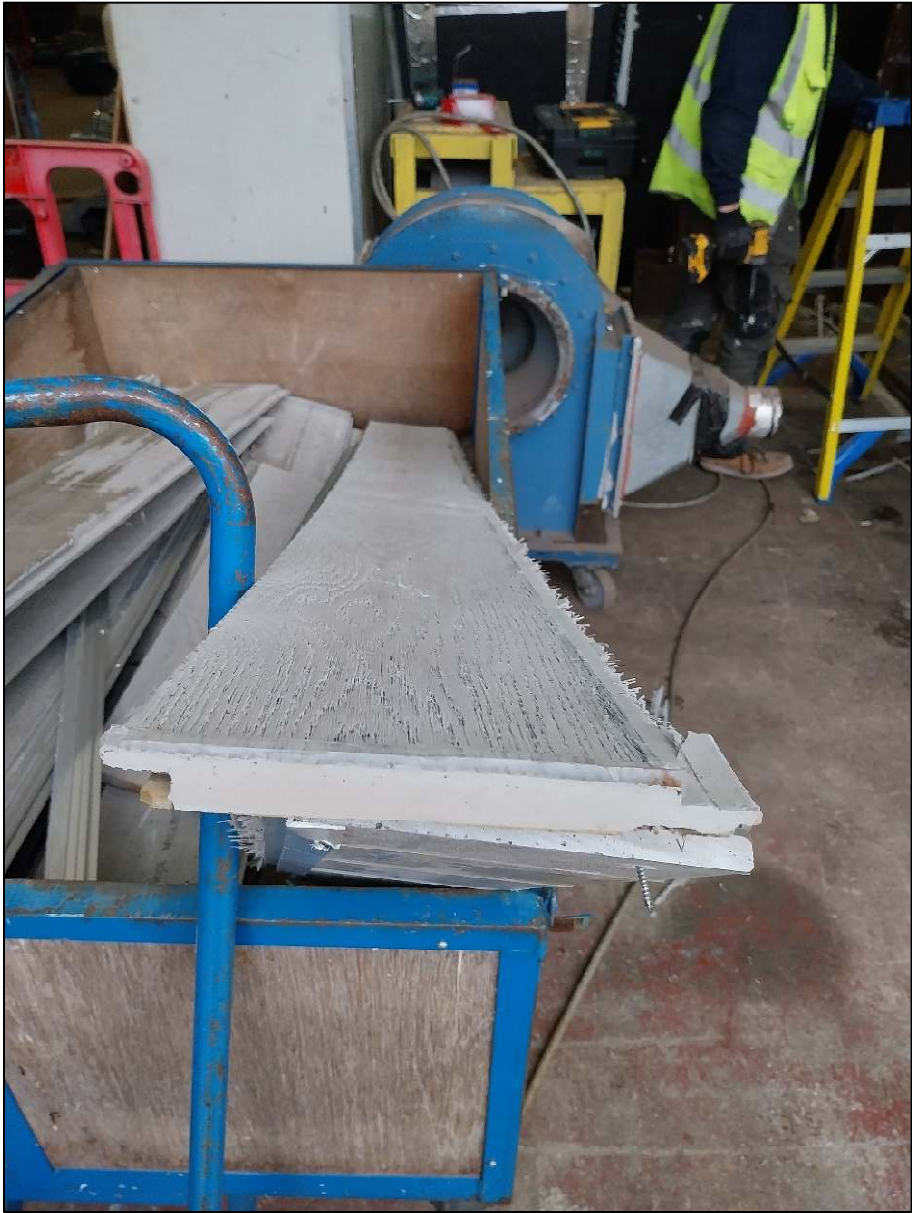
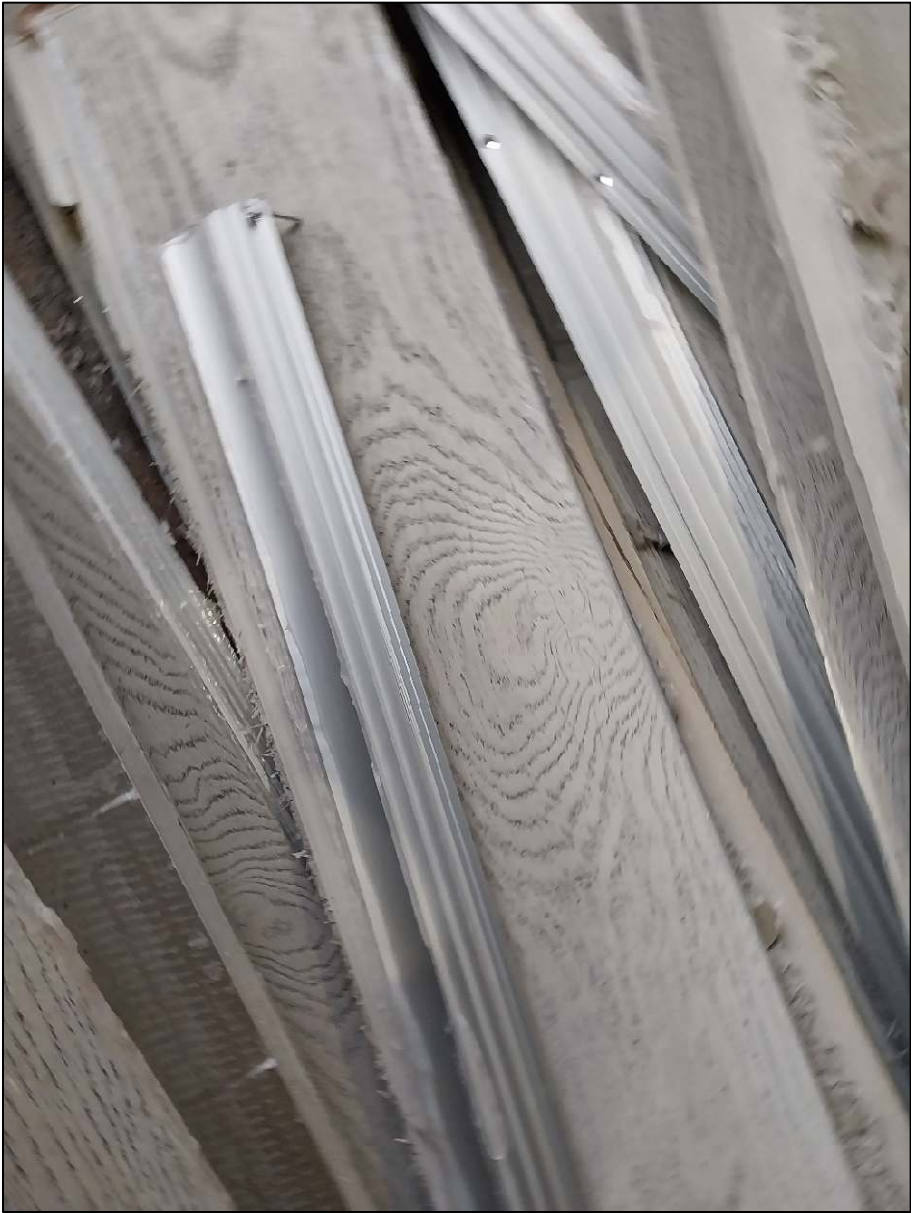
PHOTO 090315

During the dismantling of the sample no discrepancies from the drawings or damage to the support frame were found.

PLANKS REMOVED FROM SUPPORT FRAME
